Crudine Ridge Wind Farm

Biodiversity Management Plan (Operational)

28 February 2024

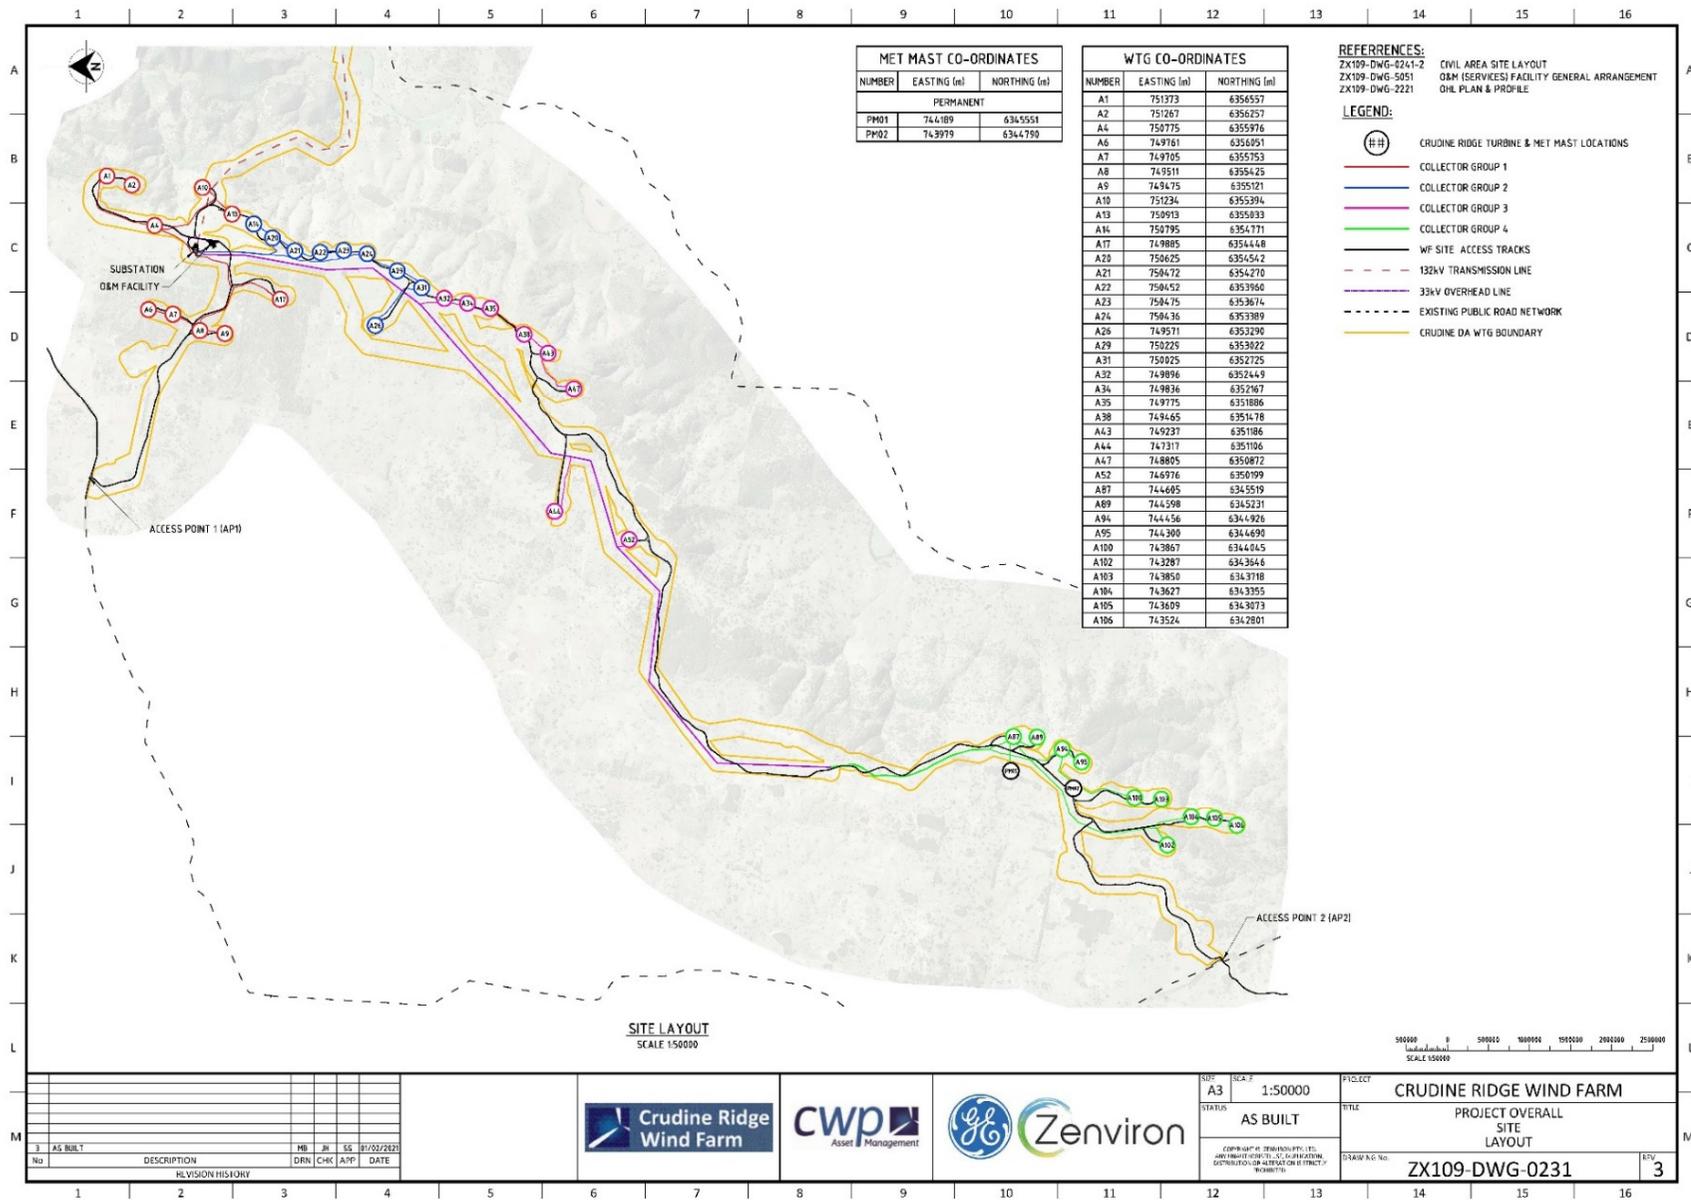
Figure 1 Approved Project infrastructure of the Crudine Ridge Wind Farm

The Project consists of 37 wind turbine generators (WTGs), access roads, hardstands, internal electrical reticulation, operations and maintenance facility, a TransGrid operated substation, and approximately 15 km overhead transmission line. A map showing the final Project layout is shown in Figure 1.

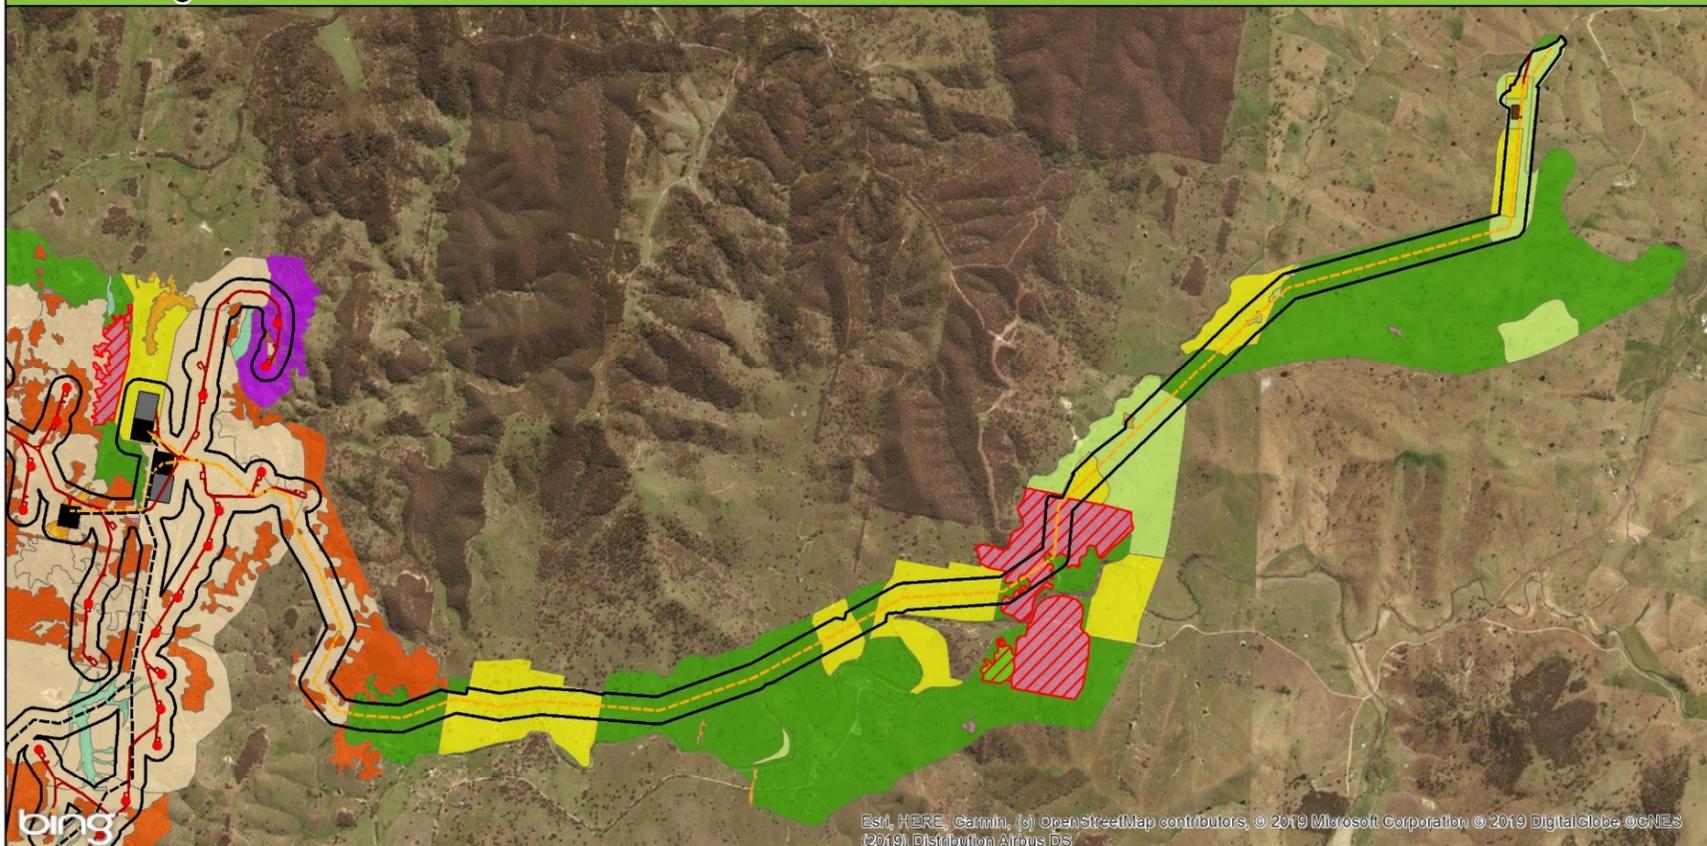
Figure 2 Vegetation types and EEC / CEEC locations – Part A

Development corridor	Turbine locations
EPBC listed vegetation communities	Internal Overhead Transmission Line
Broad-leaved Peppermint-Brittle Gum - Red Stringybark dry open forest on the southeastern highlands, Moderate to Good	External Overhead Transmission Line
Disturbed terrain, Low	Approved Layout - Internal Roads
Exotic pasture, Low	Site Compound Options
Red Stringybark-Scribbly Gum-Red Box-Long-leaved Box shrub-tussock grass open forest, Moderate to Good, Pasture	Switching Station Options
Red Stringybark-Scribbly Gum-Red Box-Long-leaved Box shrub-tussock grass open forest, Moderate to Good, Trees	Collector Substation Options
Wet tussock grasslands of cold air drainage areas of the tablelands, Moderate to Good	
White Box-Blakelys Red Gum-Yellow Box grassy woodland (Transitional), Moderate to Good	
White Box-Blakelys Red Gum-Yellow Box grassy woodland, Low	
White Box-Blakelys Red Gum-Yellow Box grassy woodland, Moderate to Good

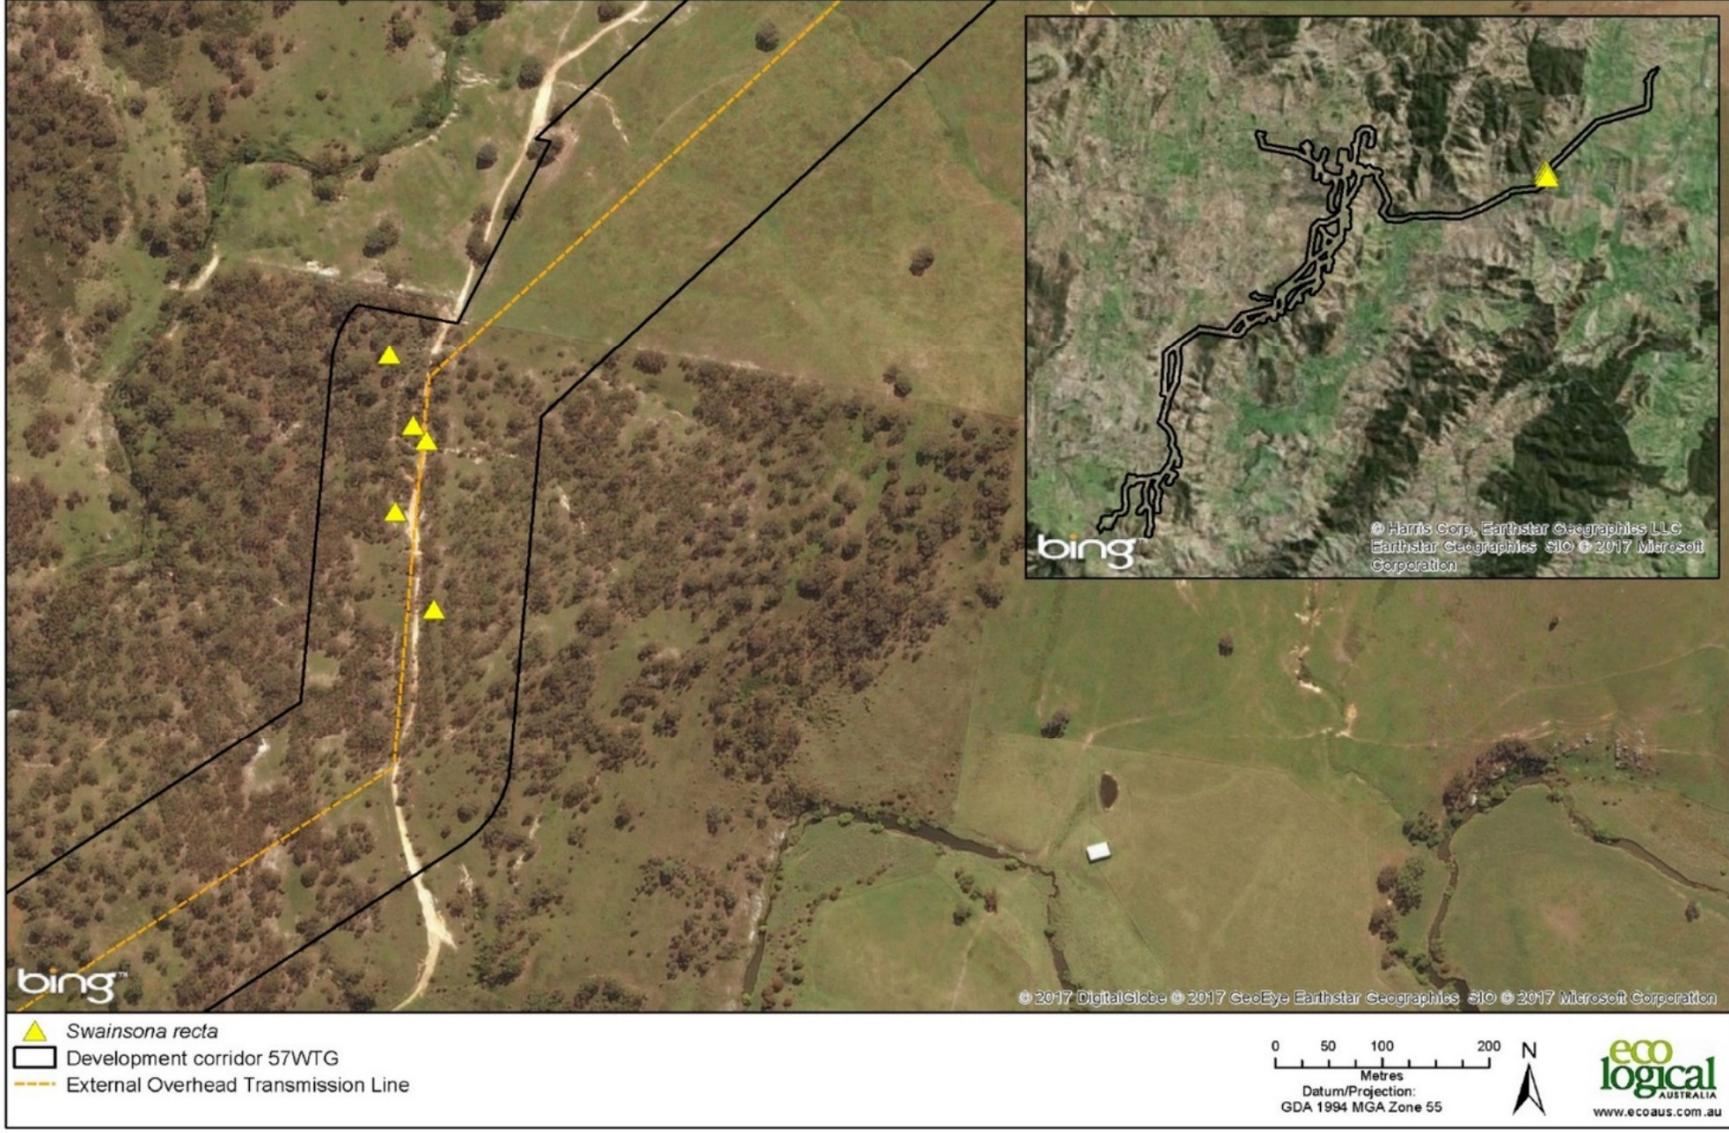
Figure 4: Swainsona recta within the overhead powerline easement

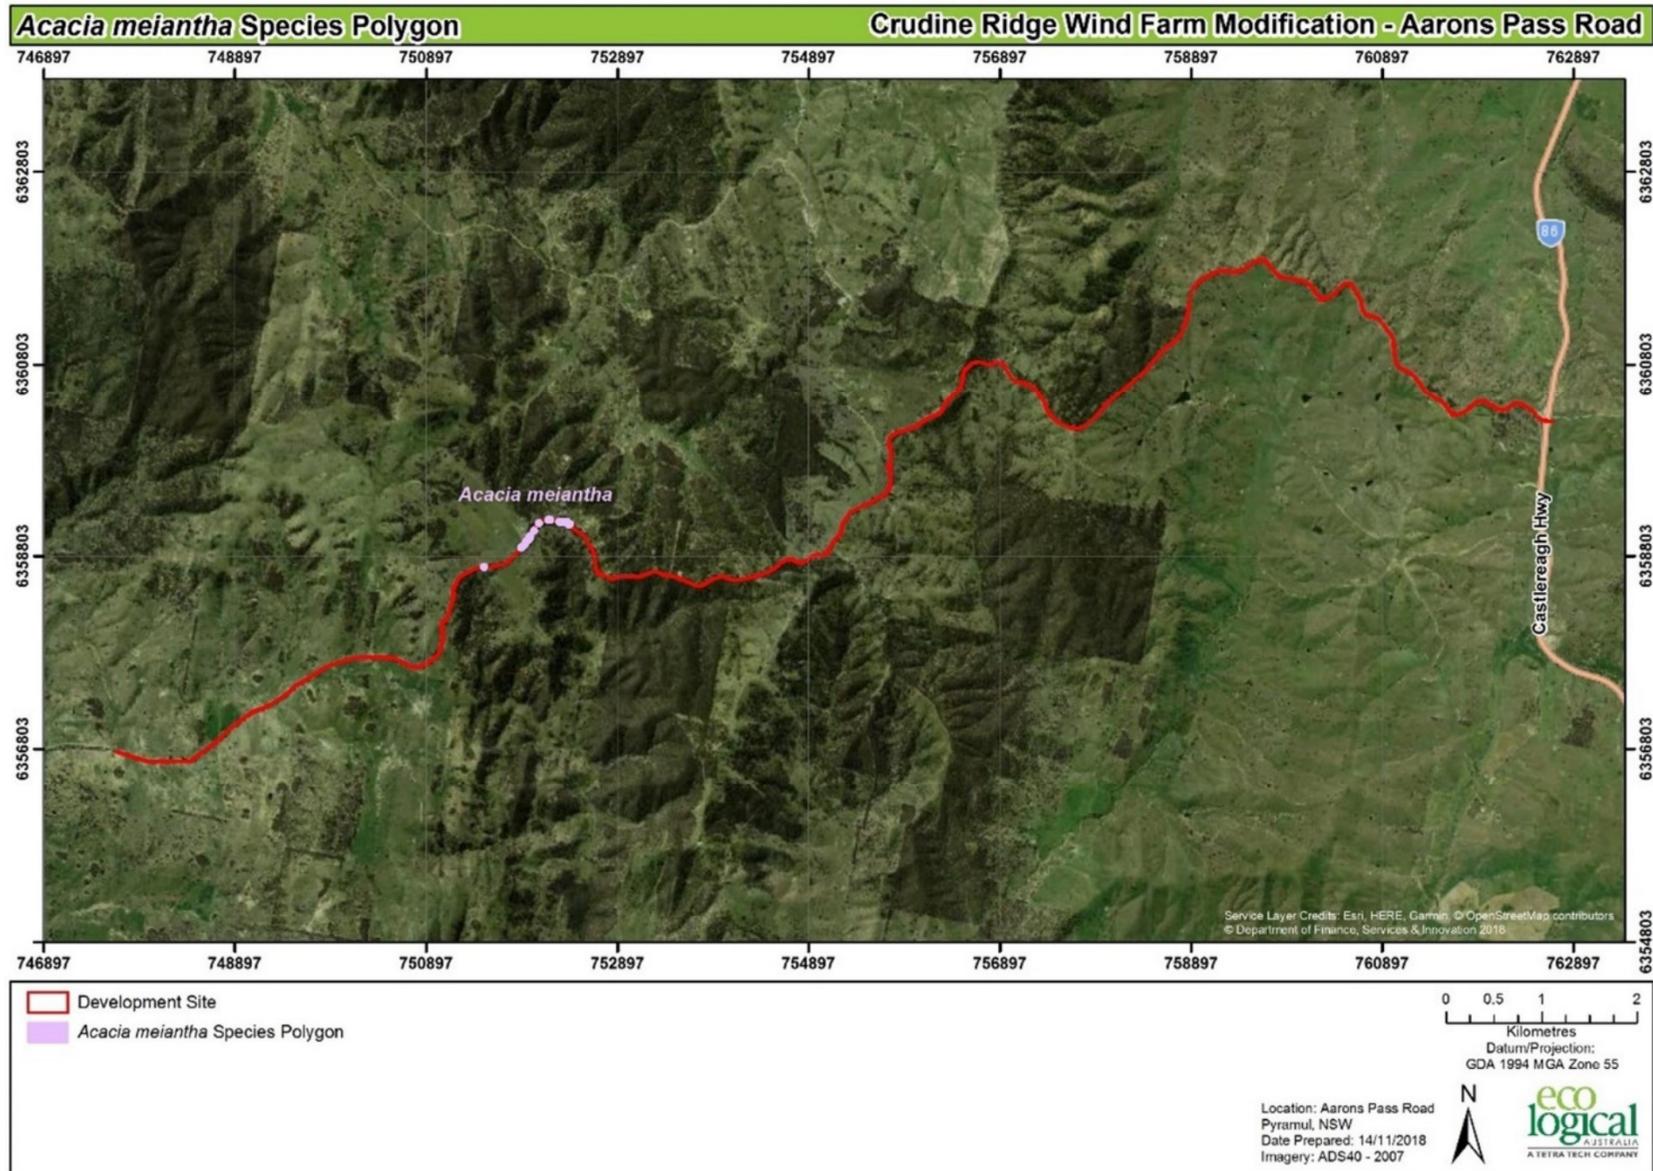
Figure 5: *Acacia meiantha* within Aarons Pass Road easement

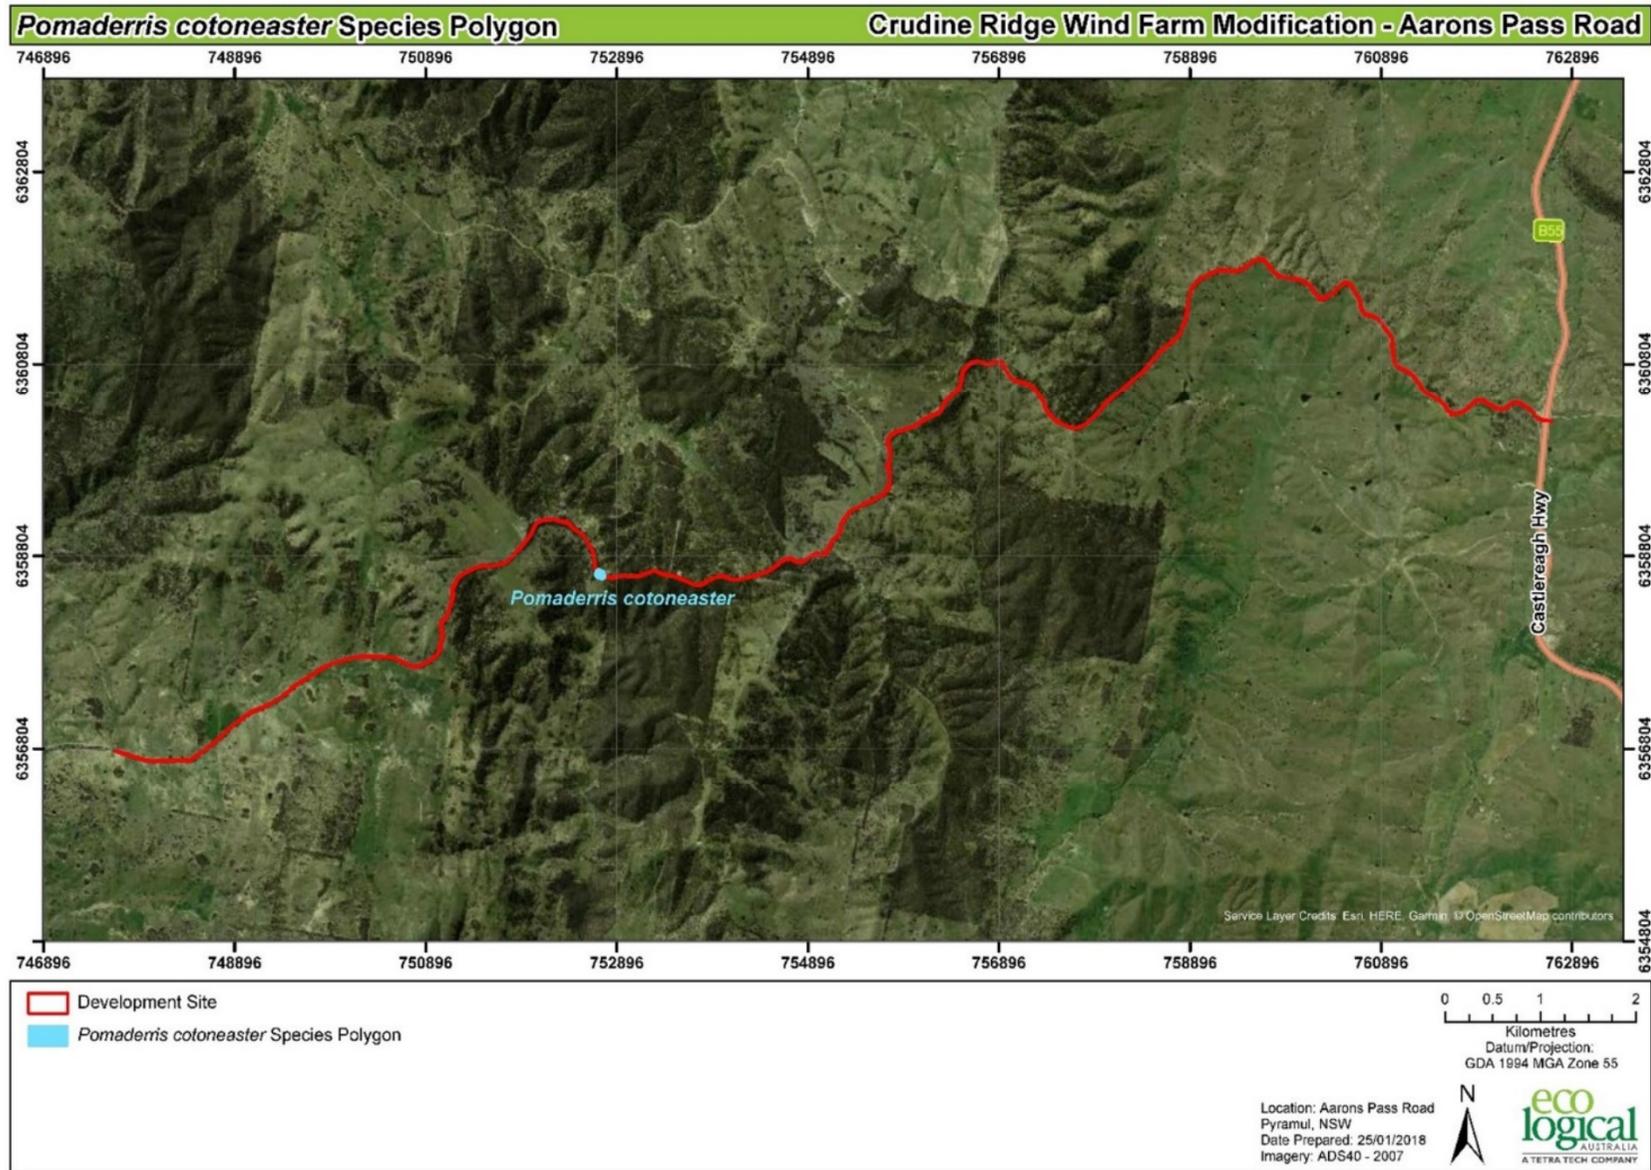
Figure 6: Pomaderris cotoneaster within Aarons Pass Road easement

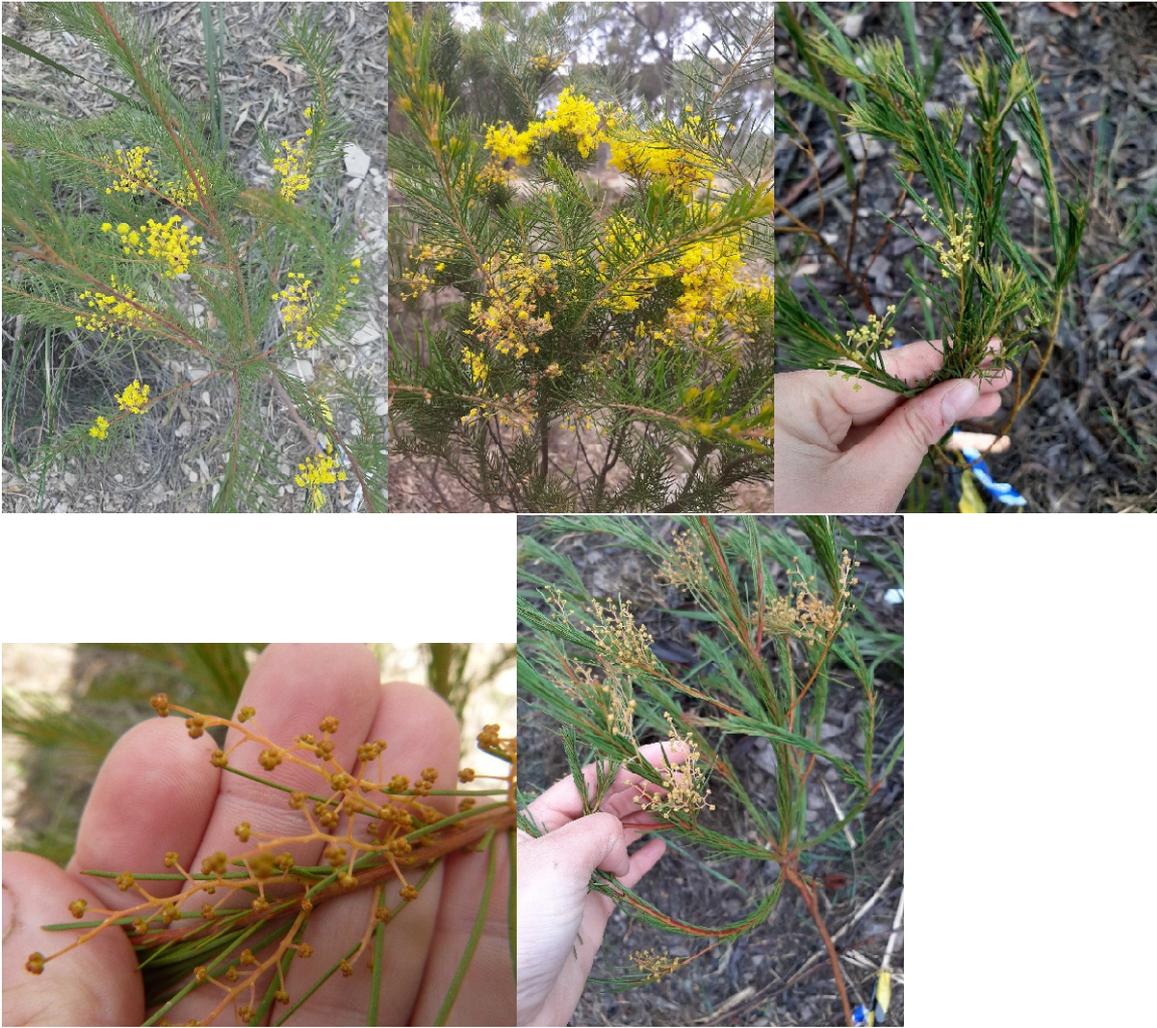
Picture 1 *A. meiantha* post translocation pictures, August 2022

GPS locations for each plant is shown in Table 9. All plants were healthy with abundant new growth. The 13 individuals were monitored weekly for two months, and then monthly for 10 months taking note of health, flowering, presence of buds, as well as any potential threats. In August 2022, the BCD inspected the translocation site with the ELA ecologist. The Translocated plants appeared to be in good condition and were in flower, as shown in Picture 1.

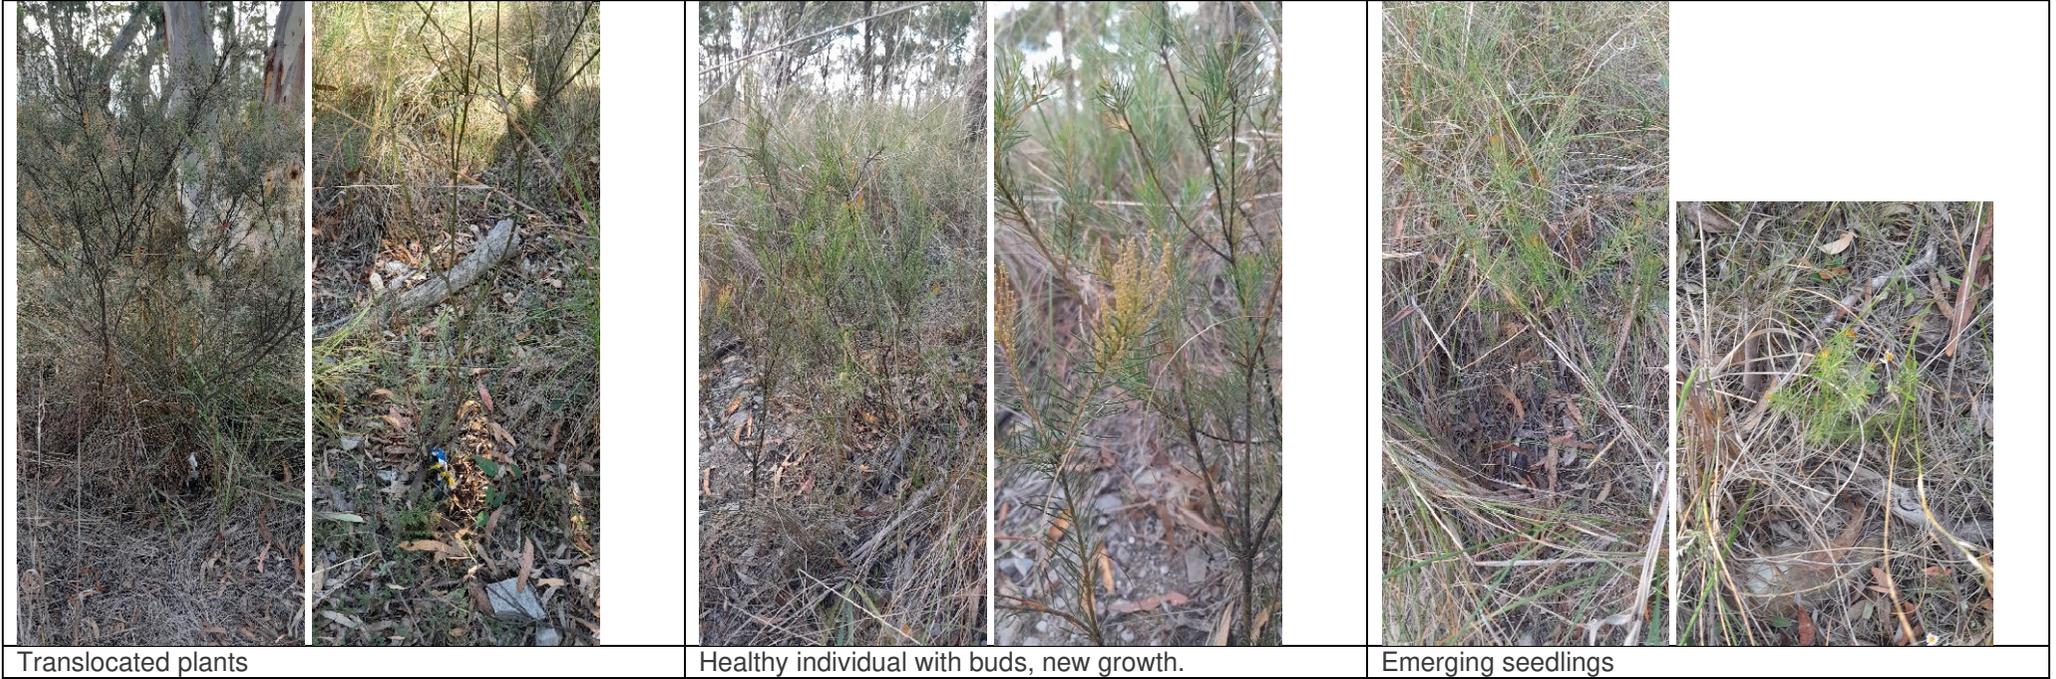
Picture 2 *A. meiantha* post translocation pictures, Febraury 2024

On 28 February 2024, the Environmental Advisor for CRWF inspected the translocated site. Five tagged translocated plants were identified. Three of these appeared dead, one appeared to be recovering with new growth, and the other was mature with buds. All other living *Acacia meiantha* did not have tags or had lost their tags. As such it was not possible to distinguish the translocated individuals from the original population. The condition of the living *Acacia meiantha* ranged from moderate to good. Some individuals had healthy green foliage and buds, whilst others appeared to be recovering and growing new shoots. New recruits from seeds were also observed. The translocation site included other native shrubs and grasses, as well as non native grasses, which appeared to be competing with the smaller *Acacia meiantha*. Other disturbances to the site included evidence of vehicles reversing into the area and crushing this variety of vegetation.

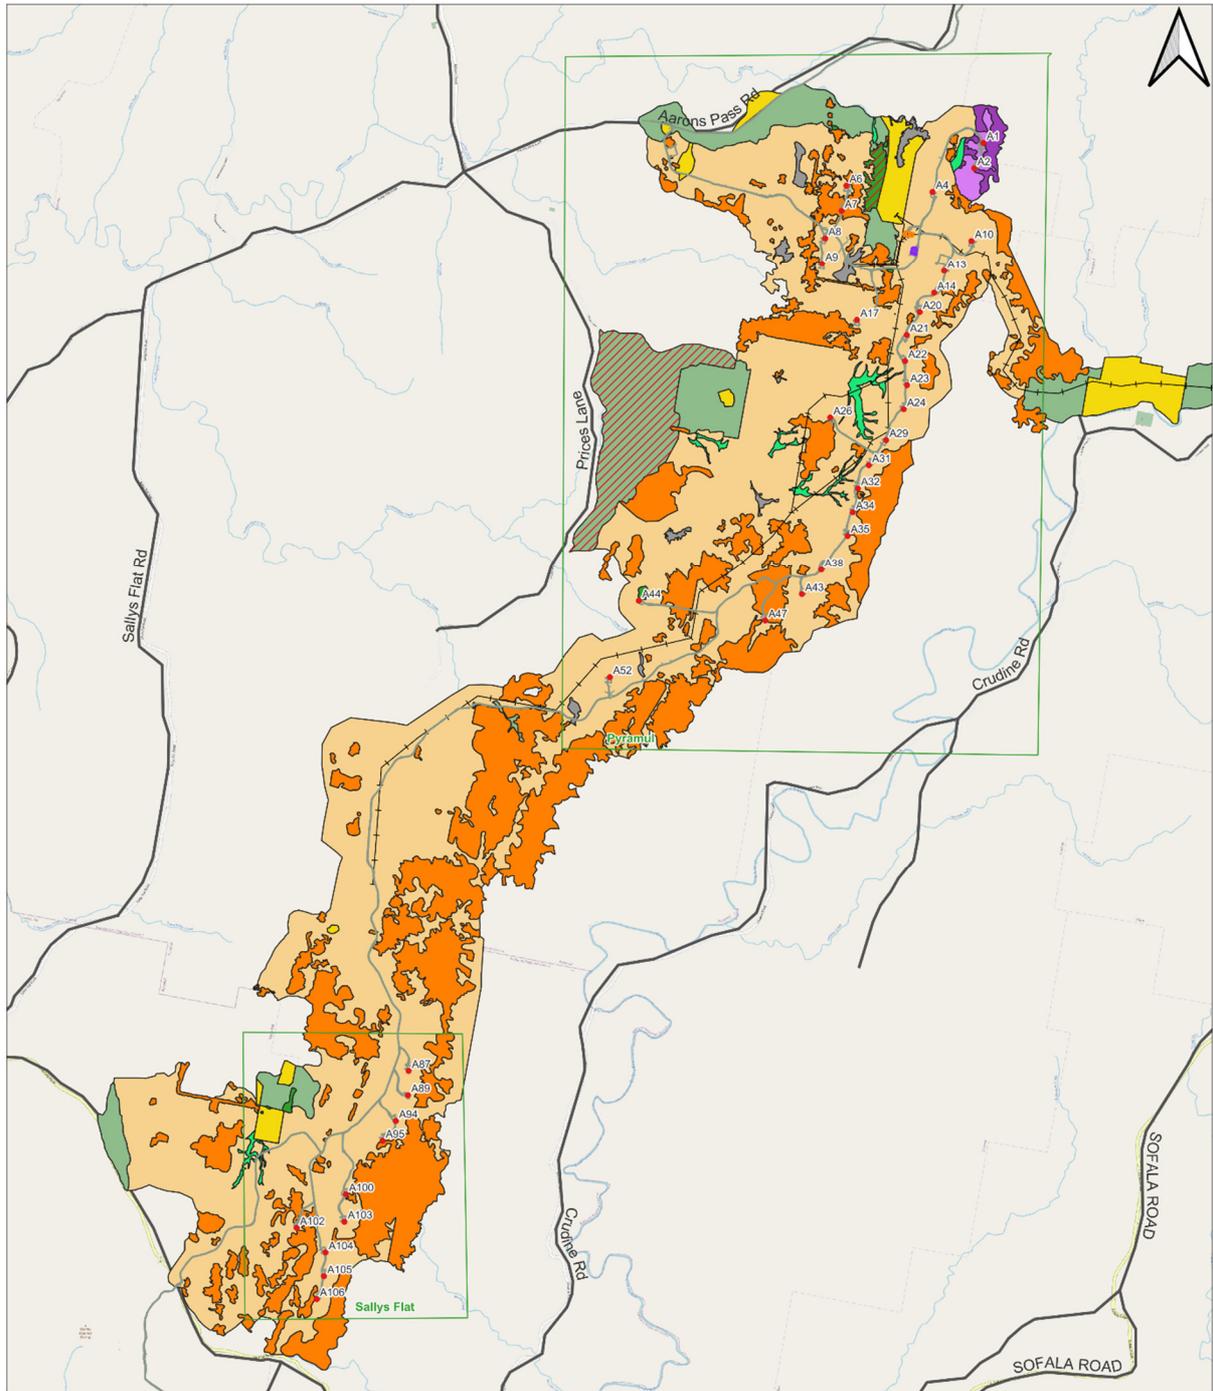
<ul style="list-style-type: none"> • WTG — O&M — Substation — OH Transmission — Roads 	Vegetation Type <ul style="list-style-type: none"> ■ Broad-leaved Peppermint-Brittle Gum - Pasture ■ Broad-leaved Peppermint-Brittle Gum - Trees ■ Disturbed terrain ■ Exotic pasture ■ Red Stringybark-Scribbly Gum- Pasture ■ Red Stringybark-Scribbly Gum- Trees ■ Wet tussock grasslands ■ White Box-Blakelys Red Gum- Pasture ■ White Box-Blakelys Red Gum- Trees ■ EPBC — Access Track 	Company		SQUADRON ENERGY	
		Crudine Ridge Wind Farm			
Title					
Operational footprint and vegetation types					
Date	Projection	Dwg No	Rev	Ver	
05/01/2024	GDA 94 Zone 55	001	001	001	
Drawn By	Checked By	Sheet	Proj Code	Size	
ZMJ		001	CRU	A3

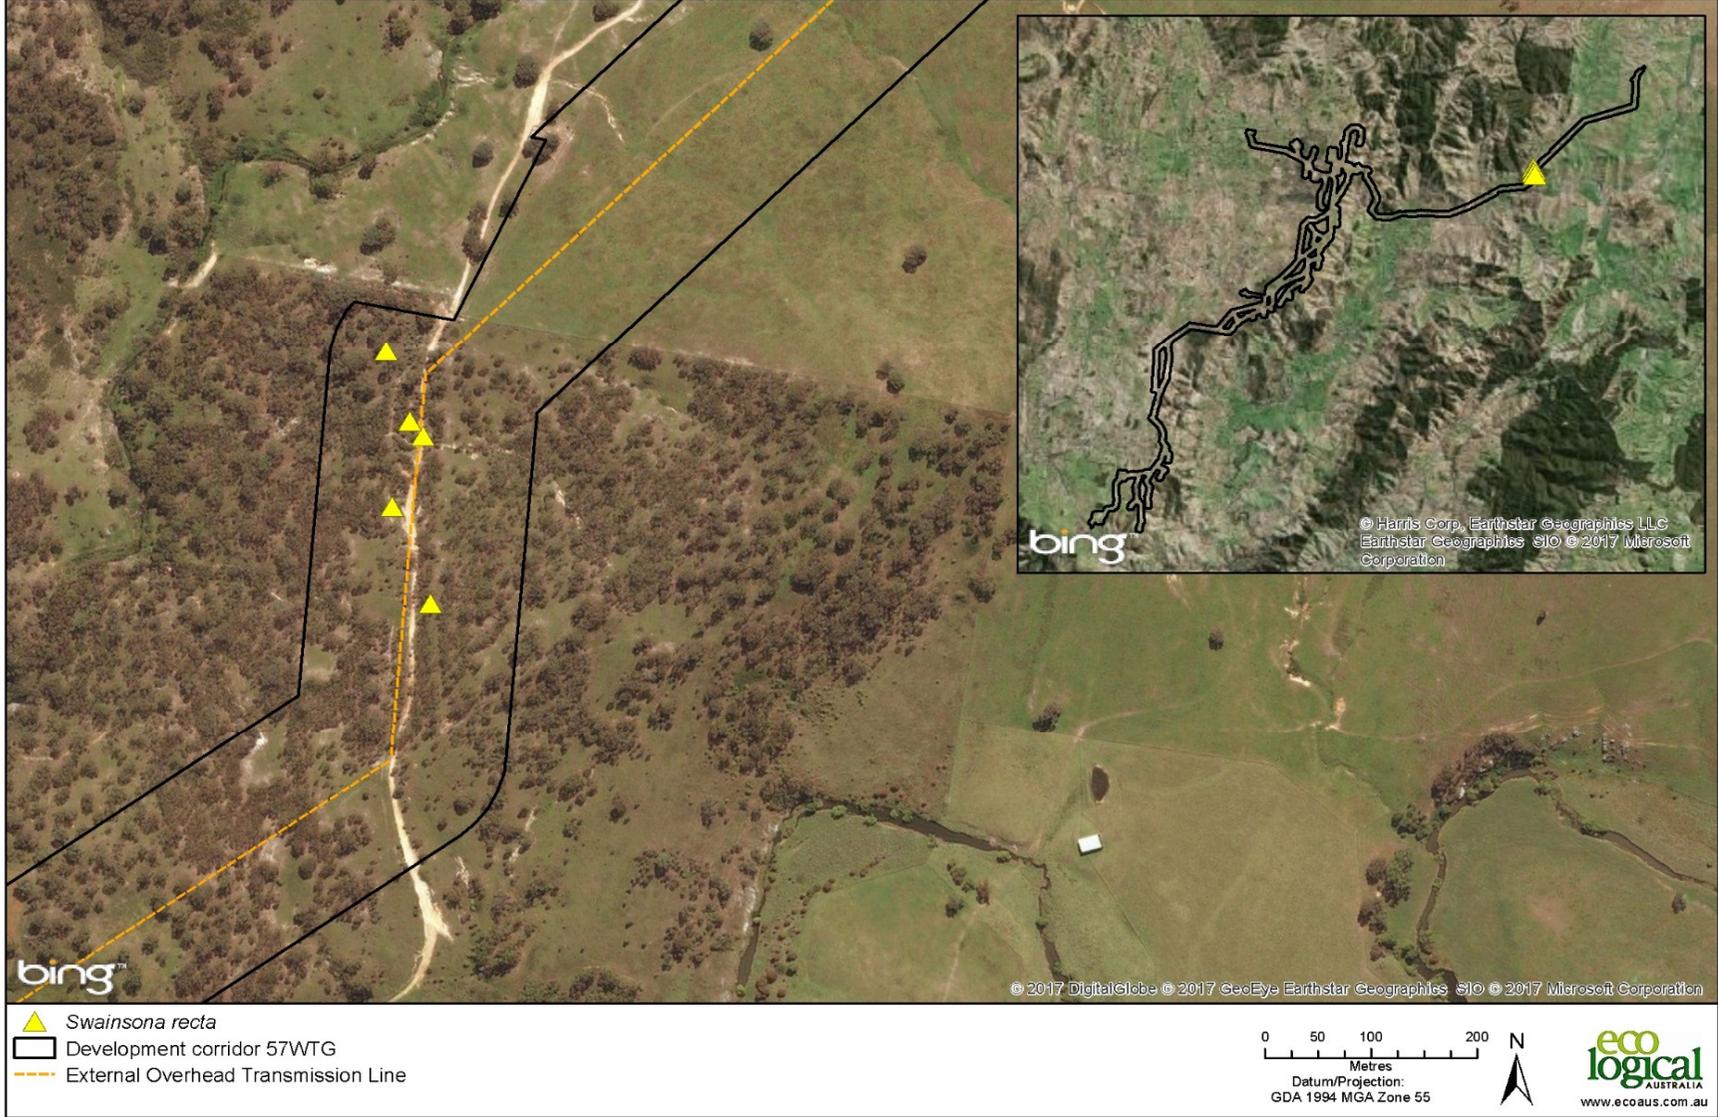
Figure 9 Known locations of *Swainsona recta*

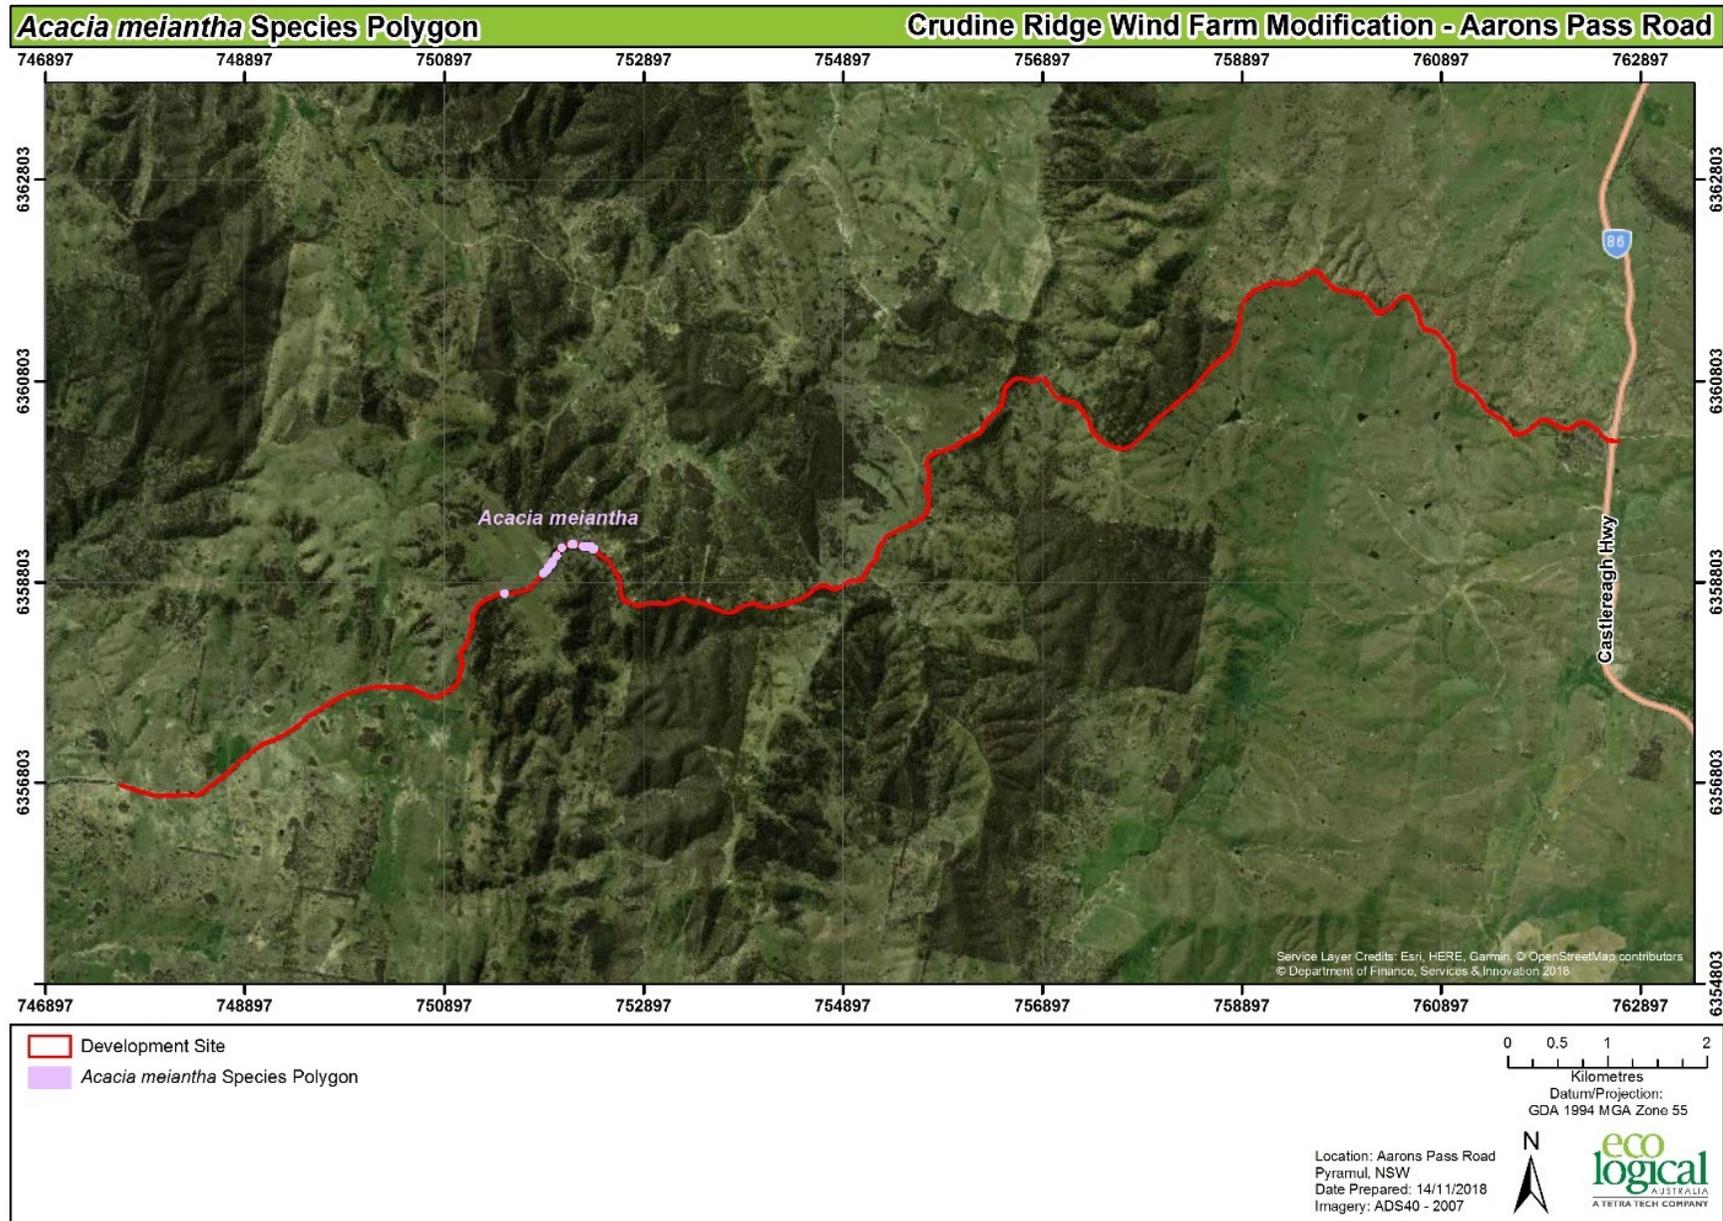
Figure 10 Location of *Acacia meiantha* along Aarons Pass Road

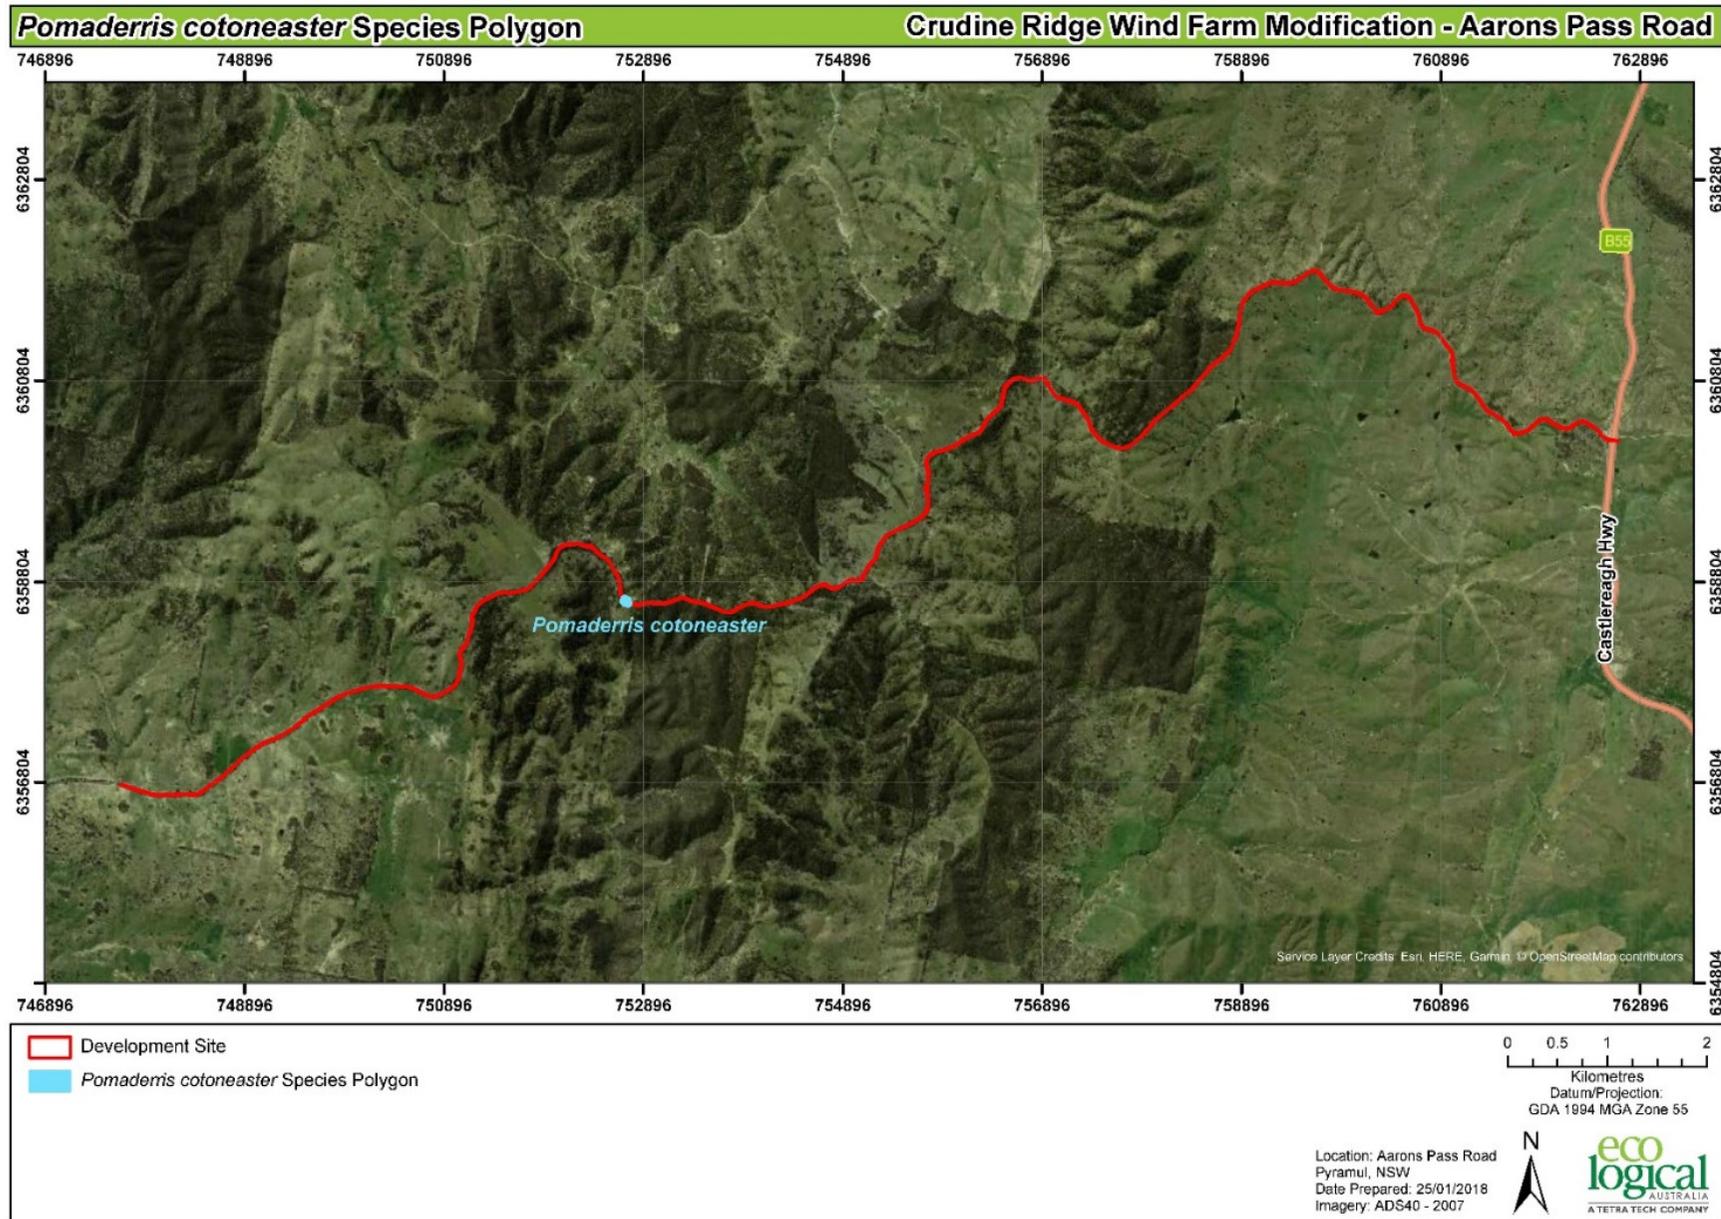
Figure 11 Location of *Pomaderris cotoneaster* along Aarons Pass Road
